The Organs in Chelveston Church

Some notes by Tina and David Hackett, and Robert Shaftoe

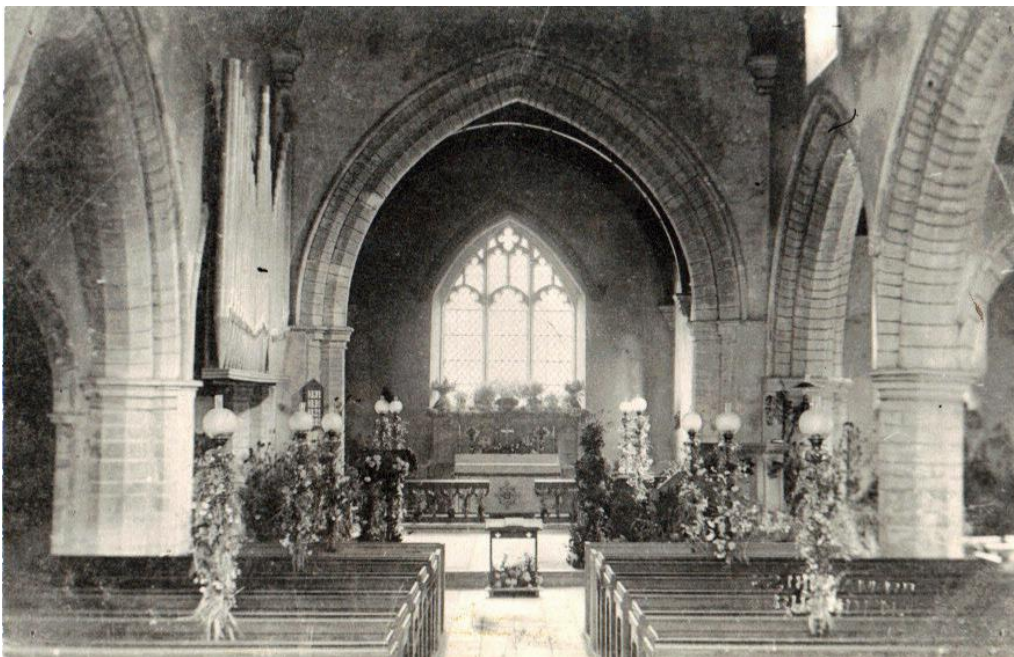
The date of the above picture is unknown, but the church is evidently decorated for harvest festival. Note the gas-lamps, and the old altar-rail and reredos. It will also be seen that the front pipes were installed in a somewhat ungainly structure, obscuring the masonry arch.

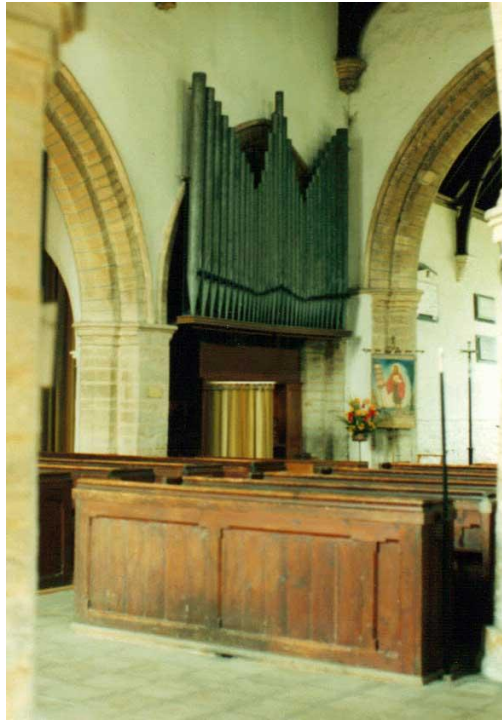
This is seen more clearly in a more recent picture, c.1980

As built, the new organ was somewhat large for a church the size of ours, and in fact for the diocese in general. ⁽²⁾ The largest of the diapason pipes were carried forward of the transept arch, on the somewhat precarious outrigger shown above. Most of the organ was built using the oldest (mechanical) system of rods and levers – the ‘tracker’ action – connected directly to the keys. However, these front pipes, as well as the pedal bourdon pipes, were controlled by the indirect ‘pneumatic’ system, whereby air is admitted to the pipe by a pneumatic motor – a sort of small bellows – which opens the valve.

Apart from the necessary rebuilding and replacement of unserviceable parts, we made one important recommendation: Robert agreed that the 'Flying' front pipes – the like of which he had never seen – spoil the impressive mediaeval feel of the church. He also expressed personal nervousness at sitting underneath the structure! We therefore redesigned the front of the organ.

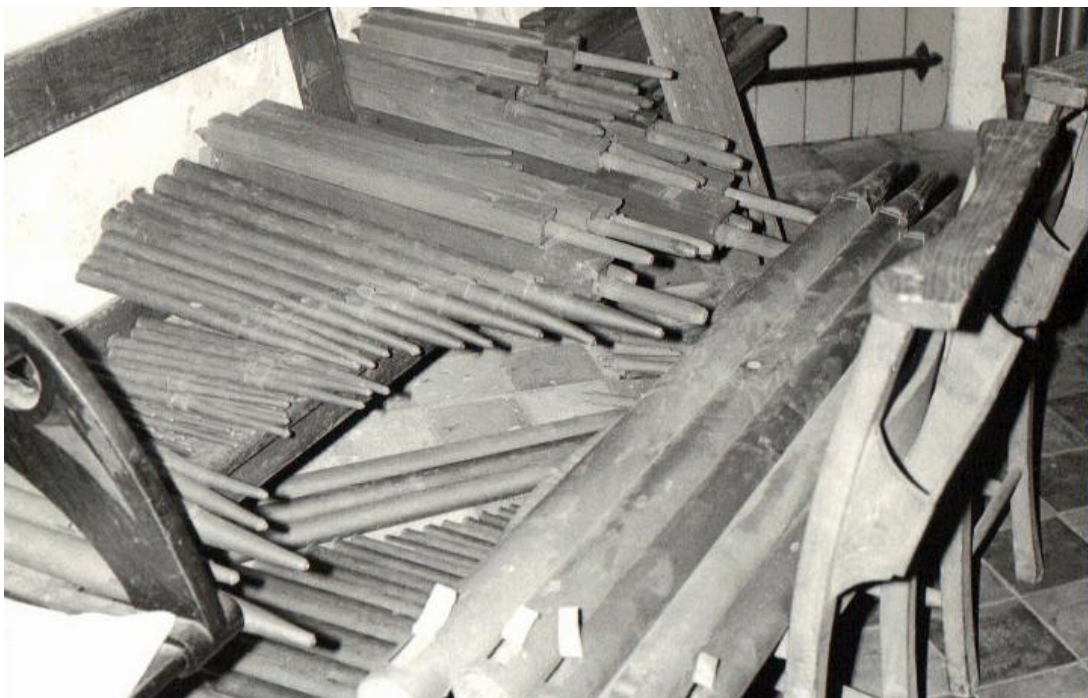
The main problem was the quantity of rubble and plaster that had fallen down from the transept roof over the years. This had entered the pipes, and the works in general. In some cases, pipes were so full of rubble they were incapable of speaking at all. The dust and grit had gradually worked its way down into the action, causing jamming of the hundreds of moving parts. One particularly vulnerable arrangement occurs when a wire tracker passes through a piece of wood, such as the interior of the windchests. The holes are conical, to minimise friction, with the wide part at the top. The smallest piece of grit will jam this completely! And there are well over a thousand of such places in this organ...

Rubble was still falling from the ceiling, so the first job was to improvise a shelter-roof. This was made from whatever materials could be found, but it was the prototype for the present more substantial arrangement.

Then the pipes were removed, emptied out, and stacked (reasonably) neatly.

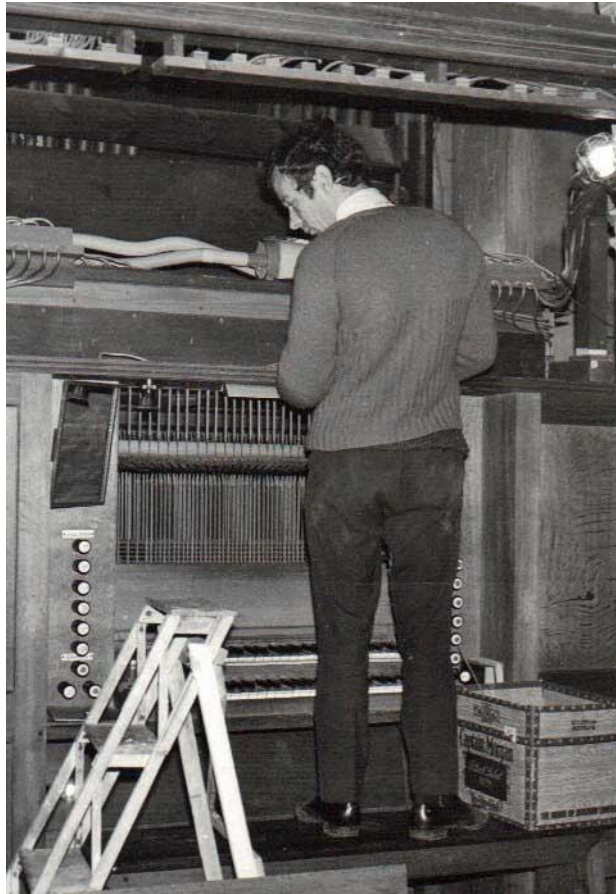
The principal tool employed at this stage was a small vacuum-cleaner, seen here in the windchest. Well over a hundredweight of dust and rubble was removed!
